# Home Report

# Scottish Single Survey

## survey report on:

Property address	The Manse Main Street Dalry Castle Douglas DG7 3PJ
Customer	Church of Scotland
Customer address	The Manse Main Street Dalry Castle Douglas DG7 3PJ
Prepared by	Shepherd Chartered Surveyors
Date of inspection	05/03/2024

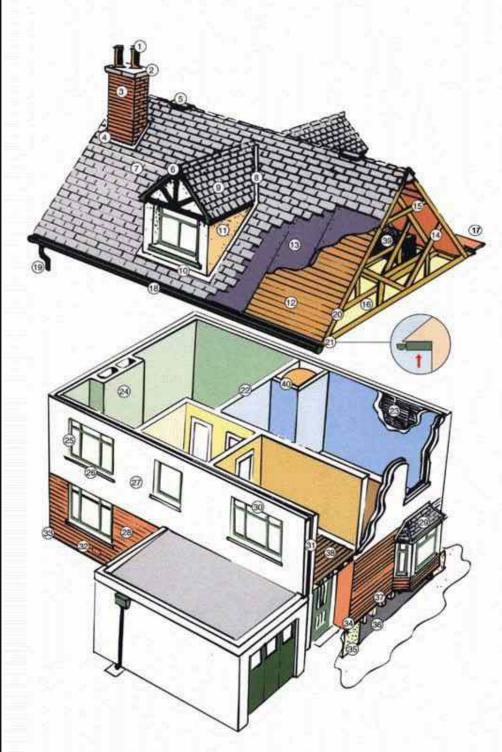
### Sectional Diagram showing elements of a typical house

Reference may be made in this report to some or all of the above component parts of the property. This diagram may assist you in locating and understanding these items.

- 1) Chimney pots
- 2) Coping stone
- 3) Chimney head
- (4) Flashing
- 5) Ridge ventilation
- 6) Ridge board
- (7) Slates / tiles
- 8 Valley guttering
- 9 Dormer projection
- 10 Dormer flashing
- 11) Dormer cheeks
- 12) Sarking
- 13) Roof felt
- 14) Trusses
- (15) Collar
- 16) Insulation
- (17) Parapet gutter
- 18) Eaves guttering
- (19) Rainwater downpipe
- 20) Verge boards /skews
- 21) Soffit boards
- 22) Partition wall
- 23) Lath / plaster
- (24) Chimney breast
- 25) Window pointing
- 26) Window sills
- 27) Rendering
- 28) Brickwork / pointing
  - 29) Bay window projection
- (30) Lintels
- (31) Cavity walls / wall ties
- 32) Subfloor ventilator
- (33) Damp proof course
- 34) Base course
- 35) Foundations
- 36) Solum
- 7) Floor joists
- 38) Floorboards
- 39) Water tank
- (40) Hot water tank
